Debris/Ice/TPS Assessment and Integrated Photographic Analysis of Shuttle Mission STS-80

*Process Engineering/Mechanical System Division/ET-SRB Branch,
Kennedy Space Center, Florida*

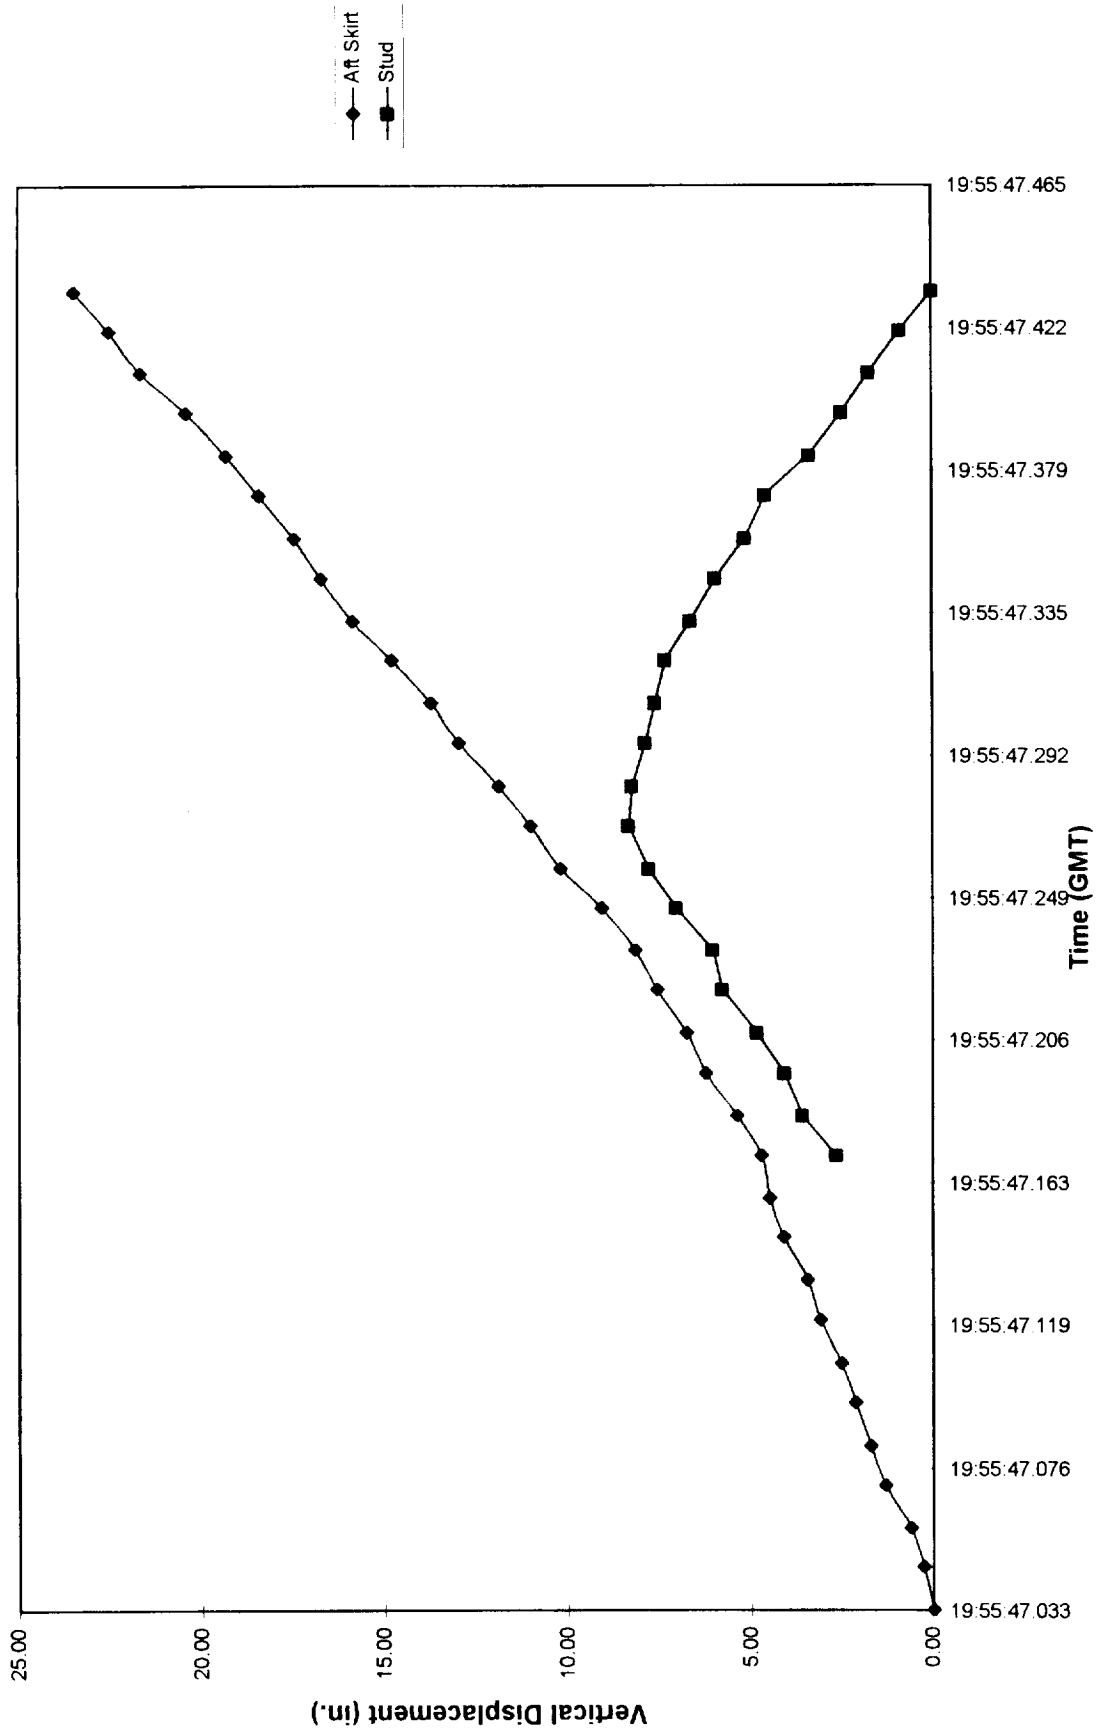
Figure 1: Holddown Post #7 Stud Hang-Up

A stud hang-up occurred on holddown post #7. Two semi-circular objects, believed to be shaved pieces of aluminum from the aft skirt bore, fell aft into the SRB exhaust hole. A piece of ordnance debris, approximately one inch long, fell from the HDP #6 stud hole shortly after lift-off. No ordnance fragments or frangible nut pieces fell from any of the other DCS while in the field of view. No stud hang-ups or frangible nut/ordnance debris was observed on any of the other holddown posts.

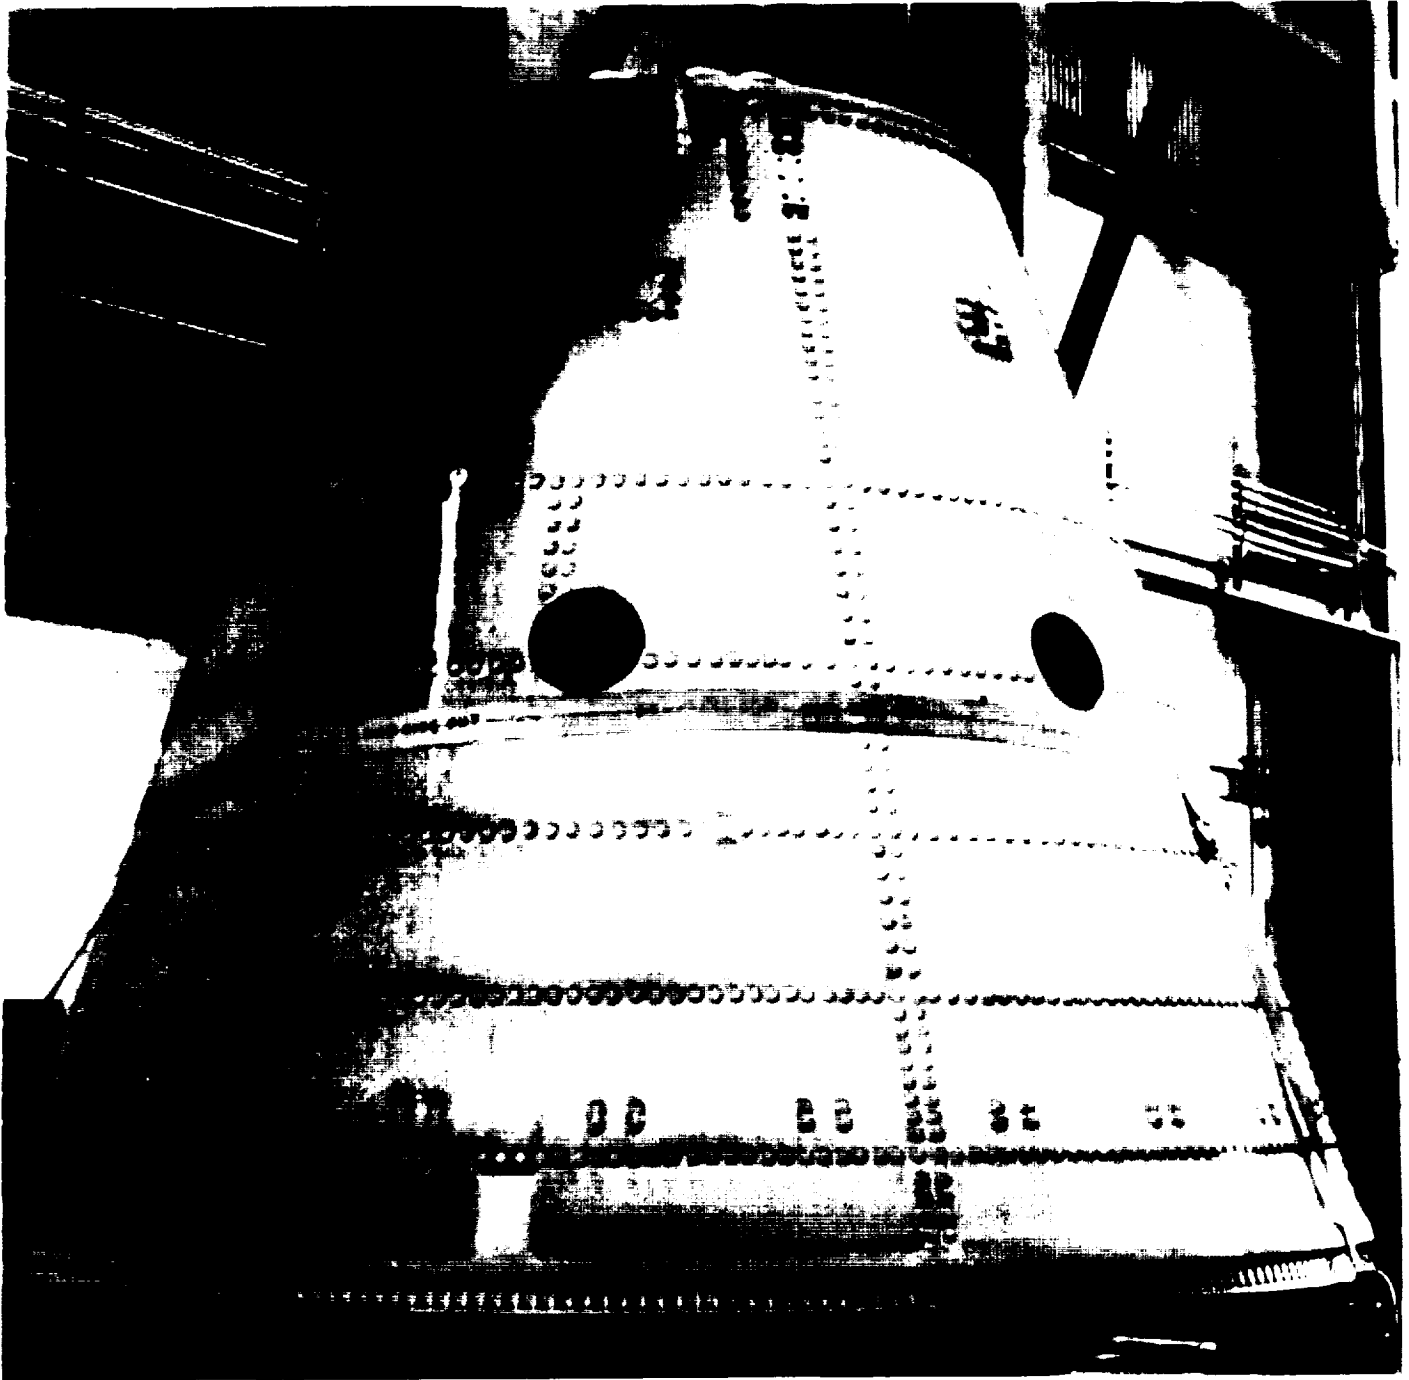
Photo 14: RH Frustum

The righthand frustum was in excellent condition. No TPS was missing. No MSA-2 debonds over acreage or fasteners were detected

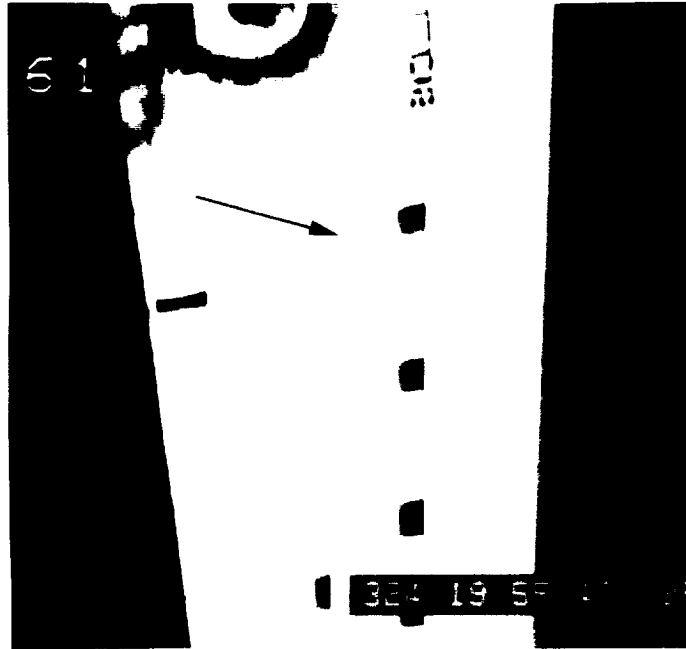
Figure 2.1 (B) Dark Debris At Liftoff

Several pieces of dark appearing debris were seen at SSME ignition. A dark piece of debris was seen falling aft along the vehicle during liftoff. A single piece of debris was seen crossing the left wing leading edge during liftoff. All of these objects were probably birds. None of the objects were seen to contact the vehicle. (Cameras OTV161, OTV163)

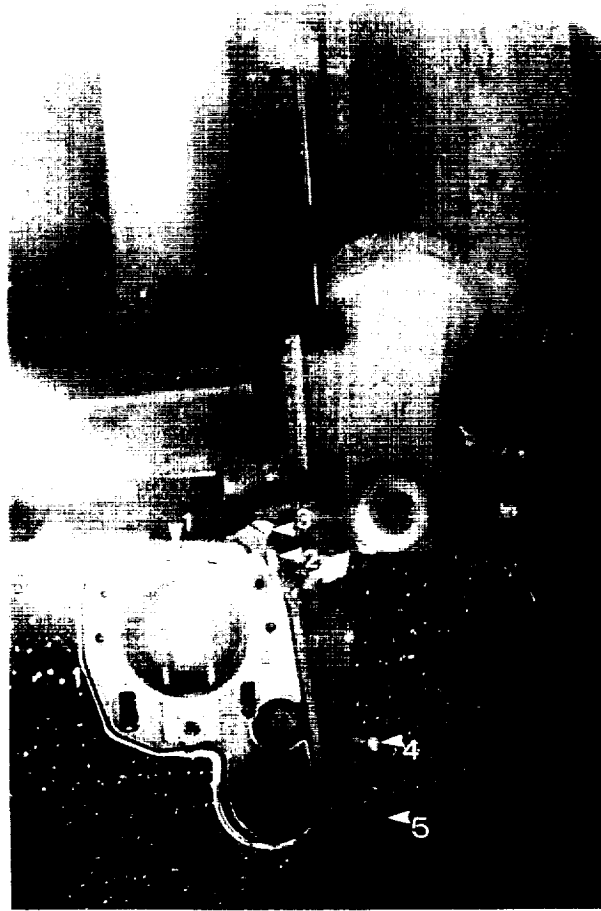
Figure 2.4.1 (B) LO2 Umbilical

Two of the five lightning contact strips (12 and 8 o'clock positions) on the ET/Orbiter LO2 umbilical interface plate were seen to be missing (1). Missing lightning contact strips have been previously seen (as recently as STS-78) and are the subject of an in-flight anomaly (IFA). A separate object (possibly RTV purge barrier material) appeared to be partially detached at the 2 o'clock position of the LO2 umbilical (2). A detached piece of insulation material (TPS) was seen at the forward right corner of the LO2 umbilical (3). TPS surface erosion/divots were noted on vertical section of the LO2 electric cable tray(4). Typical erosion or chipping of the TPS on an aft LO2 feedline flange was noted. A small light-colored string-shaped piece of debris was visible near the ET aft dome on frame 21.
